# Manhole Inspection Summary

Manhole # S17EE2031MH

**Location** Address: **1801 LOCHLEA RD**

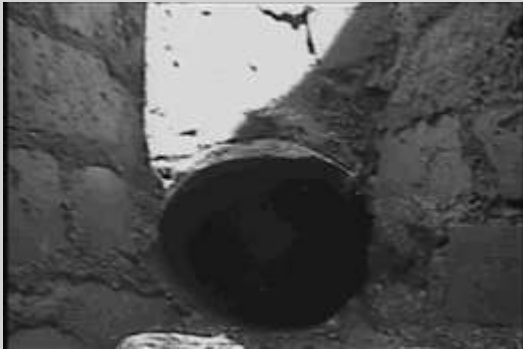
### 8 in. Circular Gravity Sewer Pipe Out @ 12 O'Clock

Pipe Material: **Clay** ☐ Pipe Lined

Invert Depth: **4.28** (ft.) Flow Characteristics: **Slow**

Infiltration: **None** Pipe Seal Cond: **Unknown**

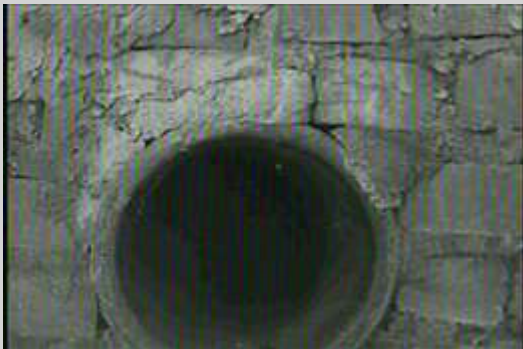
### 8 in. Circular Gravity Sewer Pipe In @ 5 O'Clock

Pipe Material: **Unknown** ☐ Pipe Lined

Infiltration: **None** Pipe Seal Cond: **Unknown**
